46TH TURBOMACHINERY & 33RD PUMP SYMPOSIA
HOUSTON, TEXAS | DECEMBER 11-14, 2017
GEORGE R. BROWN CONVENTION CENTER

SUB-SYNCHRONOUS VIBRATIONS ON A VERTICAL ELECTRICAL MOTOR DURING FACTORY TESTING – OBSERVED PHENOMENON, INTERPRETATION AND RESOLUTION

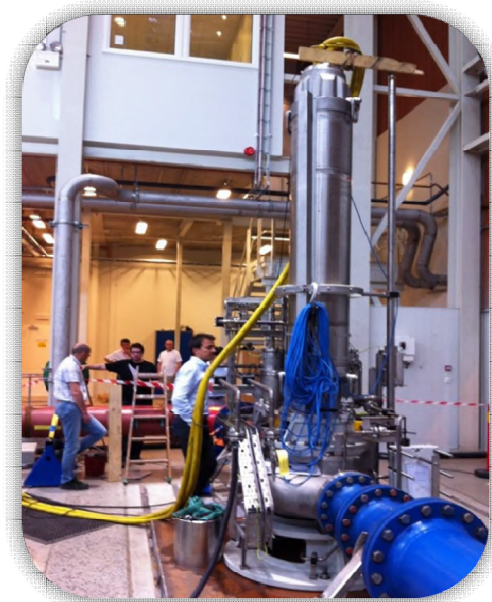
Figure 4: Complete assembly during load test

De-Ballasting vertical motor-pumps are very critical equipment for the stability of the asset and it is the reason why all 12 complete assemblies were tested in full load conditions. All packages were installed in the dry testing room and the overall performances were measured using a dedicated water closed loop to load the motors (see Figure 4).

During the load test, all motors were equipped with five (5) accelerometers to record vibration levels:

- 2 radial X and Y accelerometers on NDE side (top)
- 2 radial X and Y accelerometers on DE side (bottom)
- 1 axial accelerometer NDE side

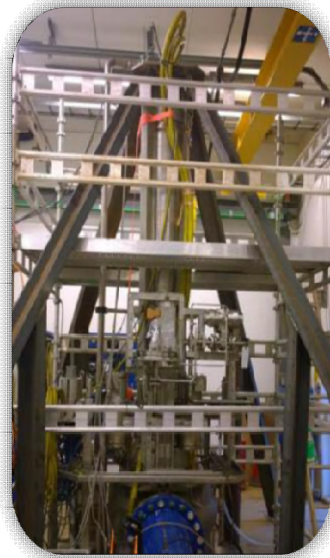
To confirm the influence of the casing natural frequency on the vibration levels, a temporary upper bracing was installed on the NDE side. The objective of this clamping system was to implement an additional stiffness into the dynamic system at the main deflecting point. The upper bracing was based on four (4) U-shape solid beams to block the NDE side as shown in Figure 7. The bump test was repeated with the upper bracing and thanks to the additional stiffness the natural frequency moved from about 12.5 Hz to roughly 20 Hz. The load test was thus repeated on Unit 11, the one that had previously shown the higher vibrations, and with the upper NDE clamping system, the vibration levels decreased from more than 5 mm/s rms to less than 1 mm/s rms, but still with a very low indication of the sub-synchronous activity.

Figure 7: Complete assembly with upper clamping system during load test

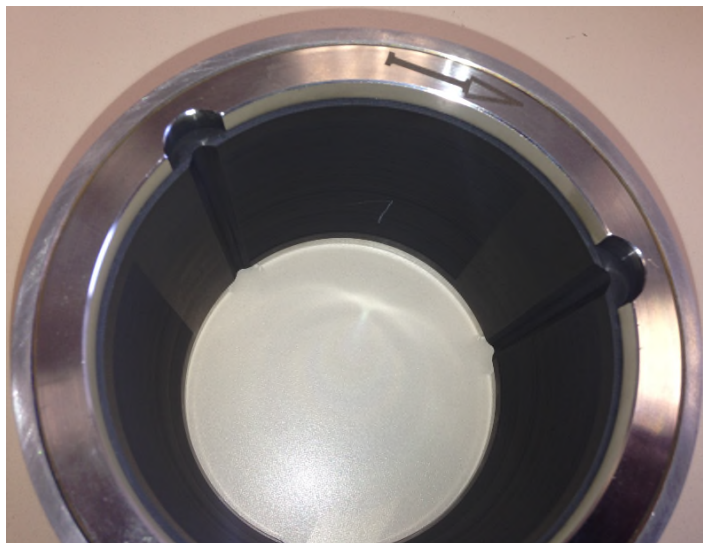
Figure 16: New bearing sleeve (Three lobes with offset)

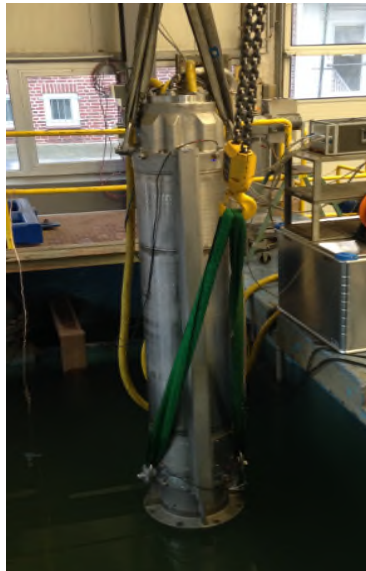
The first validation was conducted on the motor N°11 without the pump assembly. This motor was selected because it was the worse in class; refer to table 1 and figure 5. The motor by itself was suspended in the vertical direction to be tested in no load conditions and was equipped with Bently Nevada proximity probes accelerometers on DE and NDE sides. The test setup up is shown figure 19.

Figure 19: Motor N°11 in no load condition with offset sleeve bearings

The measurements were conducted up to 1800 rpm. Only the one per rev component (1X) linked to the residual unbalance was identified from BN probes and accelerometers. The vibration levels were very small, lower than 10 μm pk/pk and 1 mm/s rms, and no indication of any sub-synchronous instability was detected.

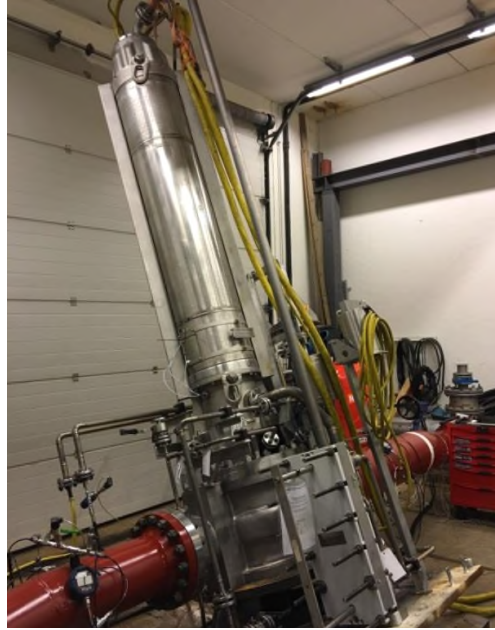
The first complete unit was extensively tested (more than 50 running hours, extreme temperature, more than 20 starts & stops, with and without upper bracing, under tilting condition up 17° from the vertical as shown figure 20). During all the testing sequence the vibrations were recorded from accelerometers and BN probes, and absolutely no sub-synchronous vibration was identified. Then the pump was disassembled for bearing inspection and, as expected, no damage was observed. The proximity probes used for this validation program were also removed as not part of the standard package prior re-assembly of the complete unit.

Figure 20: Complete assembly with new bearing, tilted by 17°, in load condition during final Factory Acceptance Test

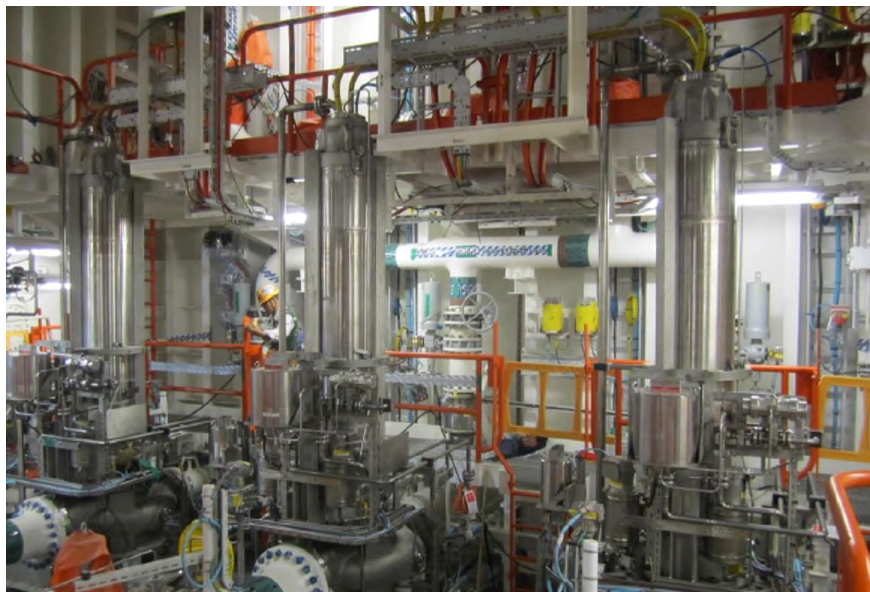
Finally the pumps were shipped back to Korea to be re-installed inside the four piles of the semi-sub platform. The figure 21 shows the arrangement inside one the machinery room with three pumps in parallel. Among the commissioning and start-up activities, a bump test without upper bracing was conducted for all 12 assemblies considering both transversal directions. The first bending mode was measured from 13.5 to 15.9 Hz, which is higher than half rotating frequency.

Figure 21: Three pumps finally installed in the machinery room of the semi sub platform
